Ultra-Premium Exterior Paints

EVERSHIELD®

EXTERIOR

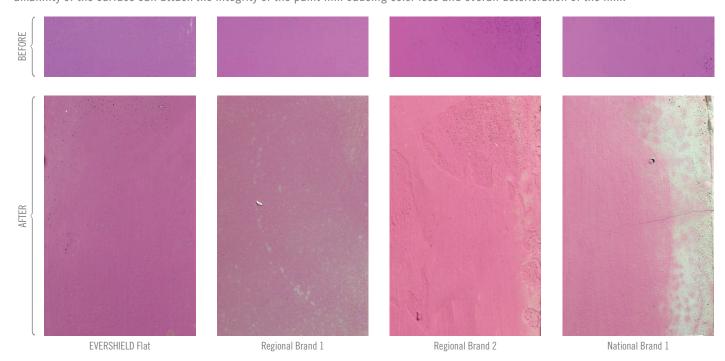
Fresh masonry is likely to contain lime, which is very alkaline (pH greater than 7). If the masonry is not allowed to cure properly, the alkalinity of the surface can attack the integrity of the paint film causing color loss and overall deterioration of the film.

Alkali Burnout Resistance Test Method: A mixture of cement, lime, and water is made and poured into a pan and allowed to cure for at least 24 hours. It is then removed by turning it upside-down and gently tapping on the pan onto a towel. The concrete block is divided into equal parts (no more than 4 samples per concrete block). One and two coats of each paint sample are applied by brush at equal spread rates and allowed to cure overnight at ambient temperature. The following day, the block is partially submerged inside a water exposure tray and exposed to UV lamps for a minimum of 24 hours or until no more changes to the film are seen. If the sample has poor alkali resistance, it will turn Bright Yellow.

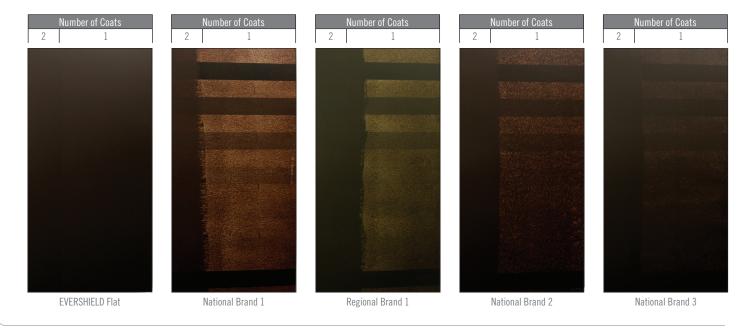
EVERSHIELD® outperforms the competition in applied hide. Good applied hide ensures that the best hide is achieved when the maximum amount of paint is transferred to the substrate from the application tool.

Applied Hide Test Method: A 4'x 8' drywall board is primed with a white acrylic primer. After allowing the primer to dry for 24 hours, varied shades of painted black to gray stripes are applied to the primed drywall (evenly spaced). After 24 hours, the first coat is applied to the test boards by roller. After 1 hour dry time, the second coat is applied and the previous consensation.

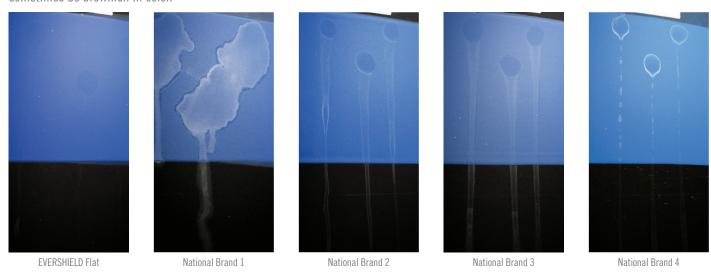
Surfactant Leaching Resistance

Surfactant leaching is the migration of water-soluble ingredients of the coating that is caused by exposure to high humidity or moisture. These areas are evident by a change in appearance of the film showing a glossy or soapy/sticky residue on the surface, which can sometimes be brownish in color.

Surfactant Leaching Test Method: A 3 mil drawdown is cast onto a vinyl chart and left to dry for 4 hours. Five drops of distilled water are placed on two spots and left to sit for 30 minutes. After 30 minutes, the panel is tilted to 90° and left to dry on a drying rack overnight. The panel is rated on the degree of any appearance change of the film from 1 (severe) to 5 (no change). The test is also repeated at different cure times to see if it improves with dry time.
